METALS HANDBOOK

VOL. 9
FRACTOGRAPHY AND ATLAS OF FRACTOGRAPHY

8th EDITION

Fractography and Atlas of Fractographs

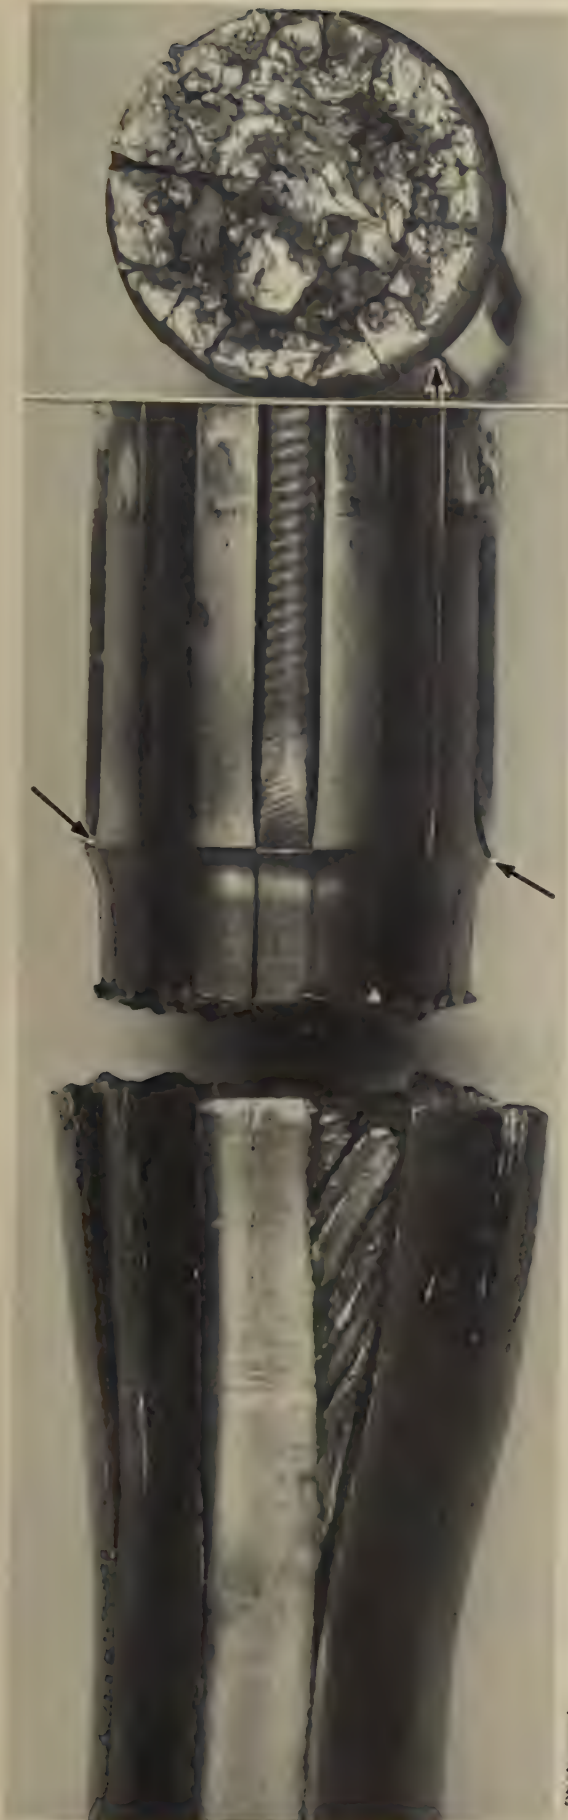
5078, 5079

At left (5078) is a fatigue fracture in the splined main drive shaft of a lift truck. The material is heat treated 8645 steel. Hardness was Rockwell C 44 throughout, except at the surfaces of some of the splines, where the hardness was Rockwell C 38. There was no apparent reason for the low hardness of these splines; decarburization, which was suspected originally, was not revealed by metallographic examination. Note the longitudinal cracks in the portion at left. Experimentally broken longitudinal sections of the shaft showed very "woody" fracture surfaces. At right (5079) is a view of the fracture surface of the right portion of the shaft in 5078. Sharpness of fillets is evident, such as at the arrows in 5078 and 5079. See also 5080 through 5082.

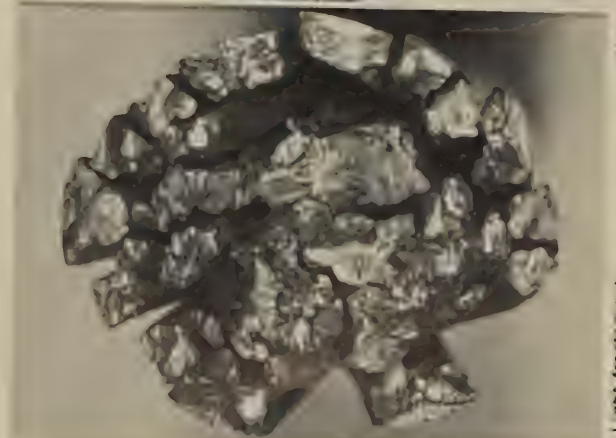
5080

Fracture surface of the left portion of the shaft in 5078 showing the badly mangled splines separated by longitudinal cracks, which are evident also in 5078 (above).

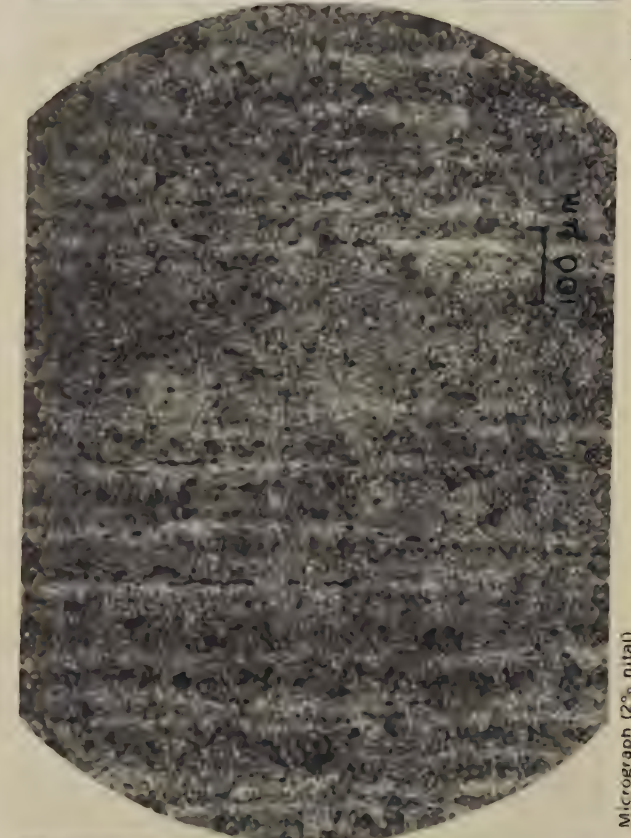
5081

Longitudinal section through a spline of the shaft in 5078, showing inclusions, banding, and some free ferrite. The cause of the fracture was improper design; corners at bases of splines had adequate radii for most of the spline length, but these radii were reduced, forming sharp angles, at points near where the splines blended with the shaft.

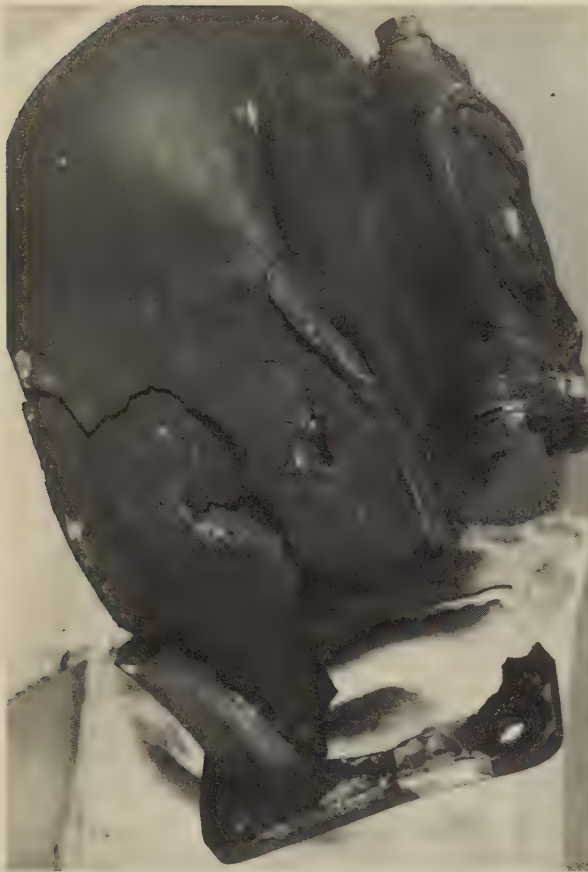
Photograph $\frac{1}{2} \times$
5083 View of a broken turbocharger housing, showing several pieces fitted together (the remaining pieces are missing). The material is ductile iron. The outer wall of the housing was crushed inward against the inner wall. Impact by a foreign object was suspected as the cause of the fracture. See also 5084 through 5087, at right and below.

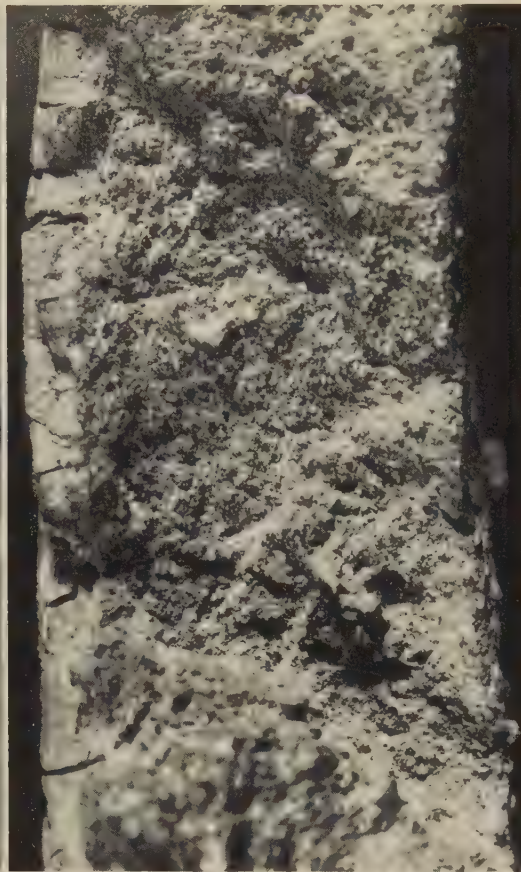
Light fractograph $10 \times$
5084 A portion of a fracture surface of the wall of the housing in 5083, showing an appearance that is typical of the entire fracture surface. The inner surface of the housing wall (at left) has a heavy layer of scale, which was caused by high operating temperature; the fracture surface has only a film of oxide.

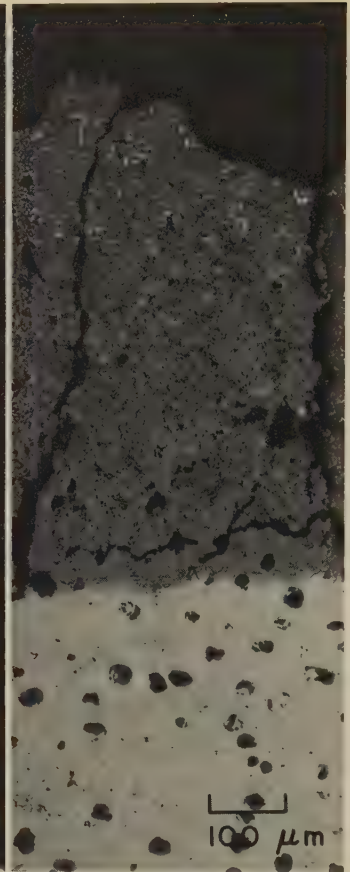
Micrograph (unetched) $100 \times$
5085 A polished section through the layer of scale visible at left in 5084, on the inside surface of the housing. Area at bottom shows spheroidized graphite nodules in a matrix of ferrite.

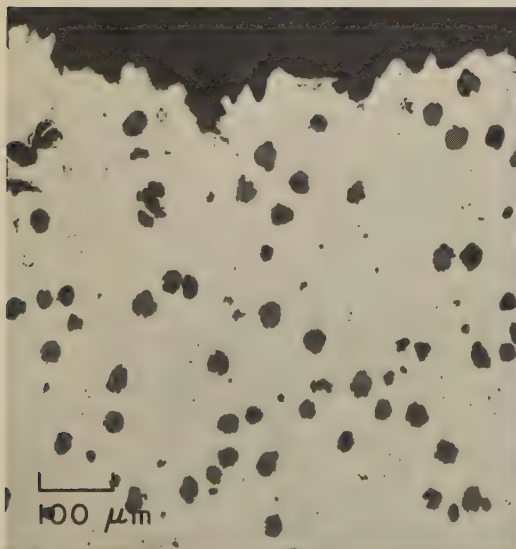
Micrograph (unetched) $100 \times$
5086 Polished section through the fractured housing in 5083 (taken in the region shown in 5084), with the fracture surface in profile at top. The lack of appreciable scale on the fracture surface indicates only brief exposure to hot gases after fracture.

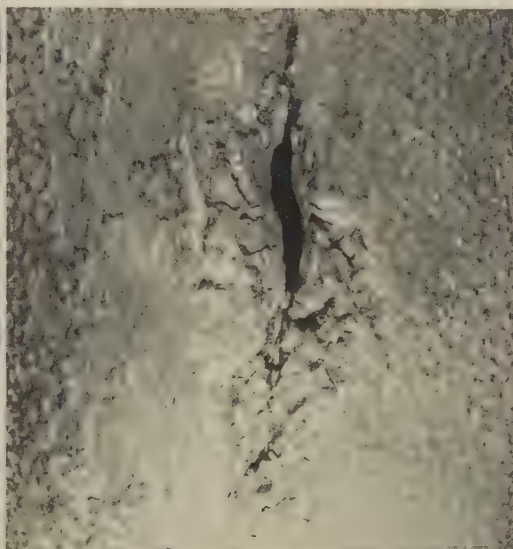
Photograph Actual size
5087 A view of a hole, which formed during service, in the housing of a turbocharger similar to that shown in 5083. Appreciable scale, which was caused by escaping hot exhaust gases, is evident in the area immediately surrounding the hole.

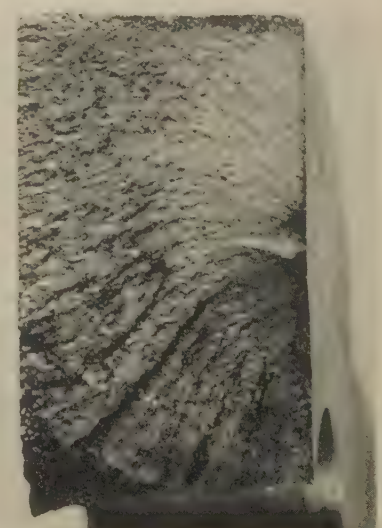
Light fractograph $2 \times$
5088 Fatigue-fracture surface of an SAE D4018 ductile iron experimental bracket (hardness, 170 Bhn max) that was broken in a laboratory. Note fan-shaped fatigue zone, and fatigue-crack origin (right edge, midheight).

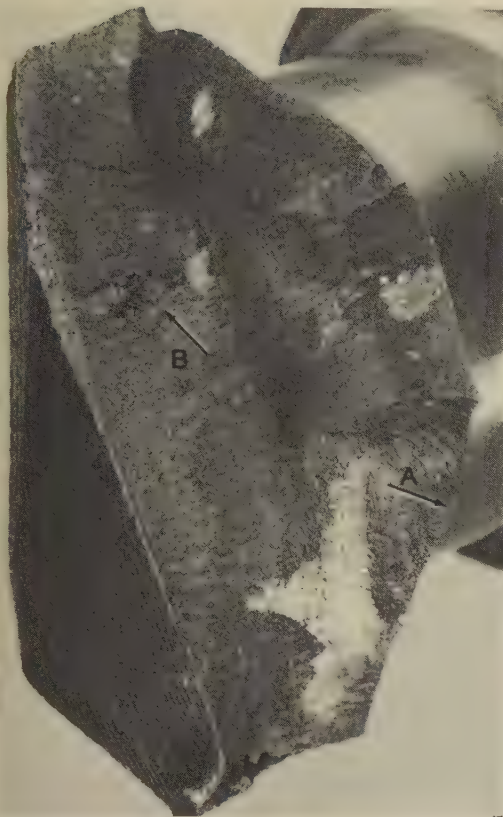
5089 Surface of a fatigue-test fracture in an experimental crankshaft of induction hardened 80-60-03 ductile iron with a hardness of 197 to 225 Bhn. Fatigue-crack origin is at arrow A. Note porosity at arrow B, which was unrelated to fracture initiation.

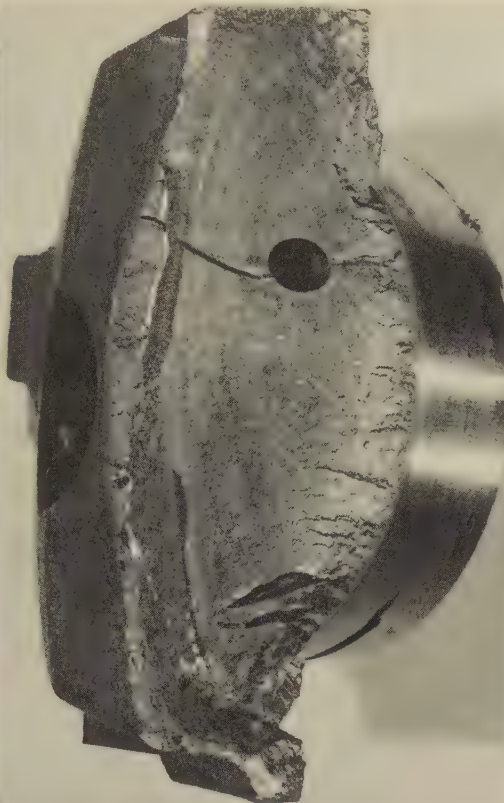
5090 Surface of a fatigue-test fracture in an experimental crankshaft of ductile iron with a hardness of 241 to 255 Bhn. Note the multiple fatigue-crack origins at the journal edge (at right). Fatigue beach marks are evident, which is unusual in cast iron.

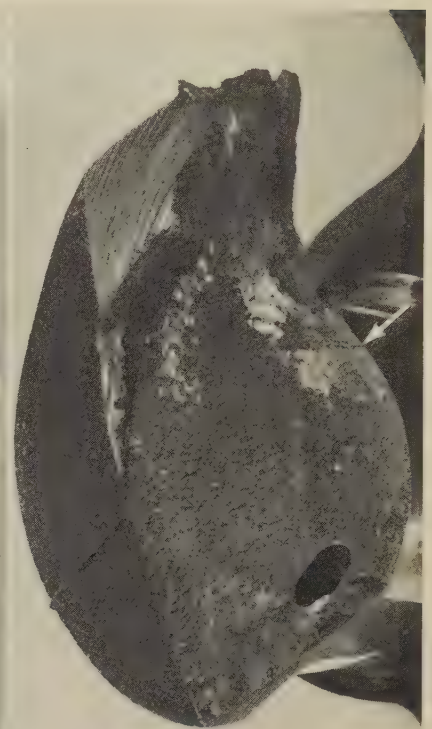
5091 Surface of a fatigue fracture in an experimental crankshaft broken in a fatigue test. The material is ductile iron with a hardness of 241 Bhn. The origin of the fatigue crack is at the edge of the journal, at arrow.

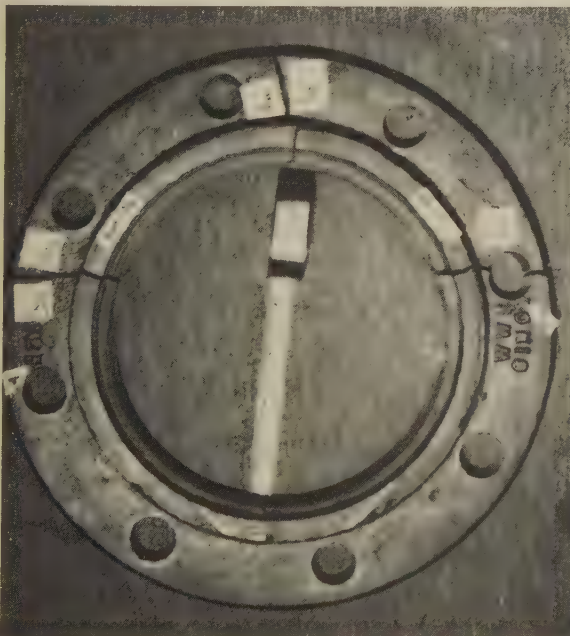
5092 View of a broken gray iron pipe flange. The fracture was attributed to stresses caused by misalignment with the pipe and by improper bolting (two bolts had to be seated partly on raised cast numerals), and to very inferior strength. See also fractograph 5093 and micrograph 5094.

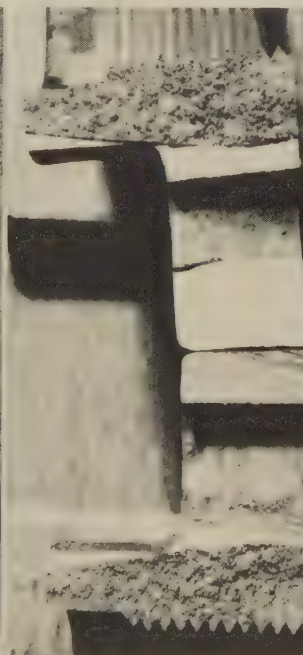
5093 Two of the coarse fracture surfaces of the pipe flange in 5092. No porosity or shrinkage cavities were discovered.

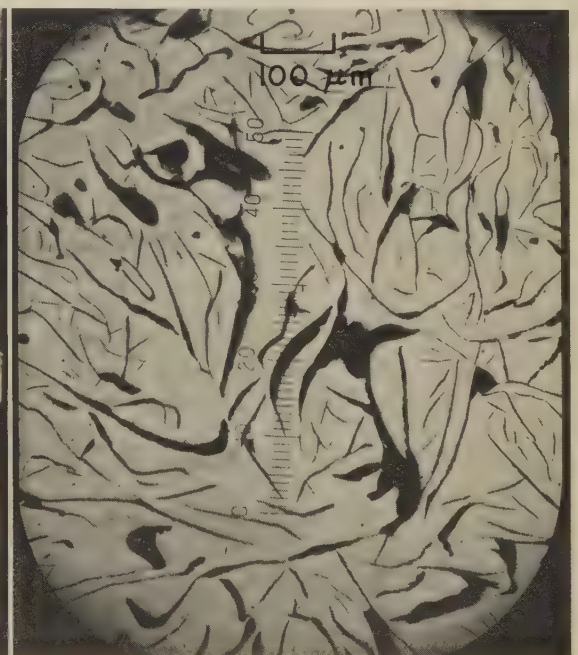
5094 A polished section through the gray iron pipe flange in 5092, showing very coarse and irregular graphite flakes; these graphite flakes, together with the low hardness of the flange (108 to 122 Bhn), resulted in low strength.

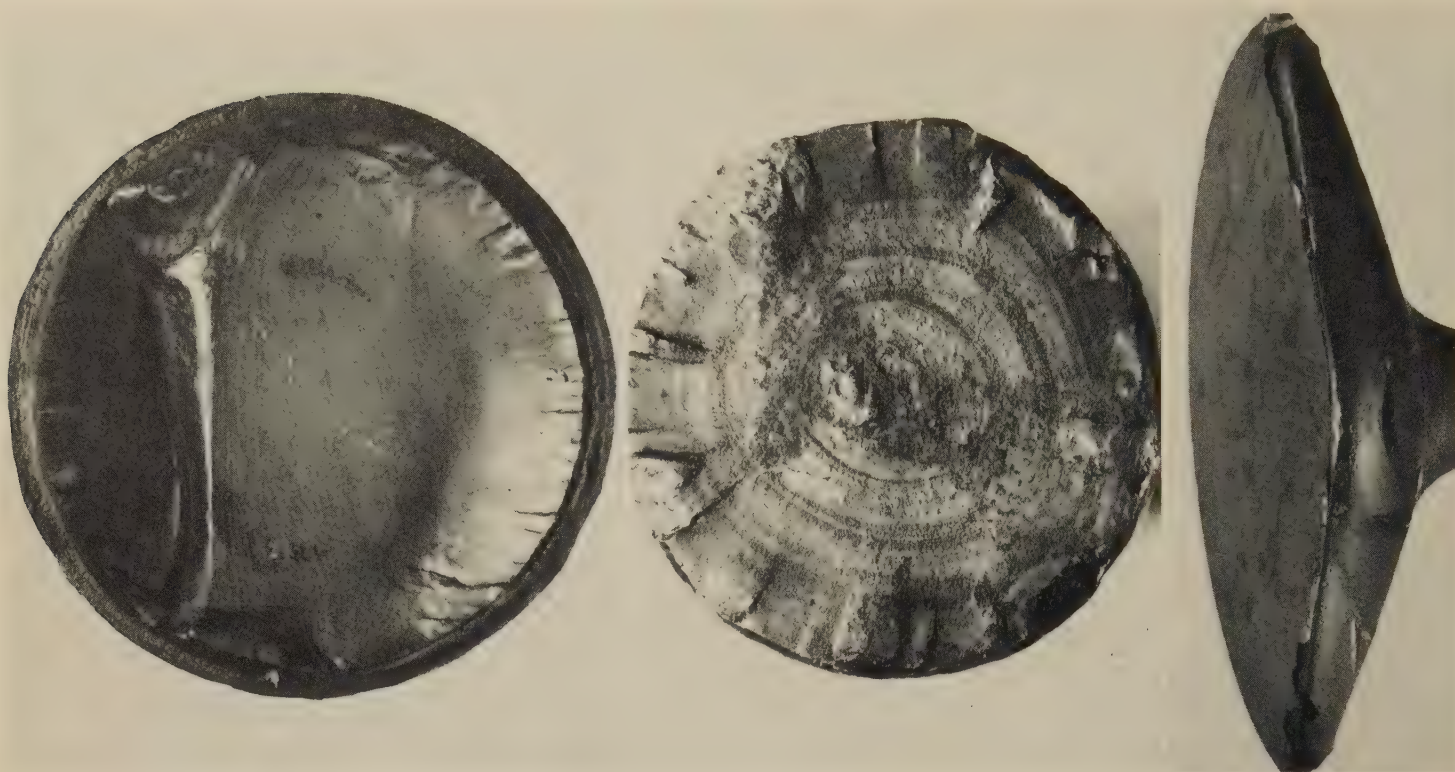
5095, 5096, 5097

Surfaces of fatigue fractures in three automotive intake valves forged of Silcrome-1 steel (0.45% C, 3.25% Si, 8.5% Cr) and heat treated. At left (5095) is a transverse fracture in the stem of a valve with a hardness of Rockwell C 37. The stem rocked within the valve retainers, initiating many fatigue cracks around the periphery of the stem; these cracks later joined to form two main crack fronts. Very well-defined beach marks are visible in the fatigue zone at right. At center (5096) is a transverse fracture in the stem of a valve with a hardness of Rockwell C 38. The stem rotated in the valve retainers, which initiated many fatigue cracks around the periphery of the stem; these cracks penetrated nearly a third of the way to the center of the stem before uniting into a single circumferential crack front. At right (5097) is a fracture in the head of a valve with a hardness of Rockwell C 37. The fatigue-crack origin is at right, at the head-stem juncture. Note the peeled surface layer.

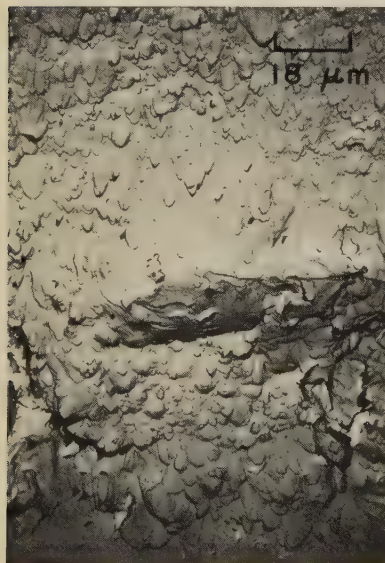
TEM fractograph (p-c replica) 550×
5098 View, at a shear lip, of a fracture surface of type 410 stainless steel wire that had been austenitized, quenched, tempered at 204 C (400 F), then broken in tension at room temperature. Shear dimples below quasicleavage area at center are less flat than those elsewhere. See also 5099.

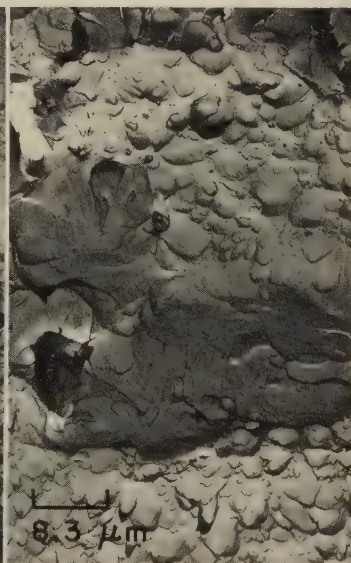
TEM fractograph (p-c rep.) 1200×
5099 A view of the mating fracture surface to that shown in fractograph 5098 (at left), but at a different area of the shear lip, turned 180°, and at a higher magnification, clearly exhibiting a quasicleavage facet surrounded by shear dimples.

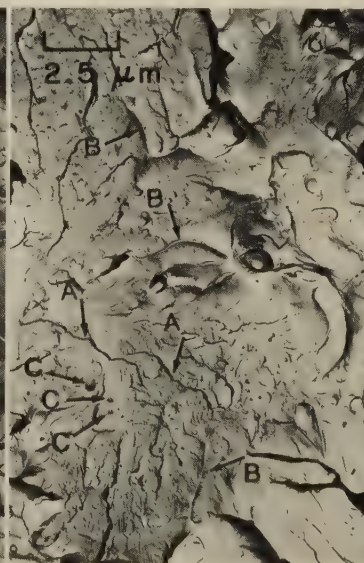
TEM fractograph (p-c replica) 4000×
5100 Quasicleavage facets in the surface of a fracture in type 410 stainless steel wire hardened, tempered, and then broken in tension at 10 C (50 F). Arrows A point to steps such as those found in true cleavage; arrows B, to tear ridges; arrows C, to tongues.

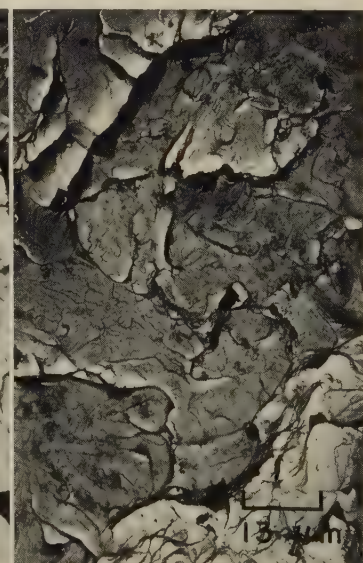
TEM fractograph (p-c replica) 750×
5101 Quasicleavage facets in the surface of a fracture in type 410 stainless steel wire that had been air cooled from 954 C (1750 F), tempered 2 hr at 510 C (950 F), notched, then broken in tension at room temperature. A few dimples are present also.

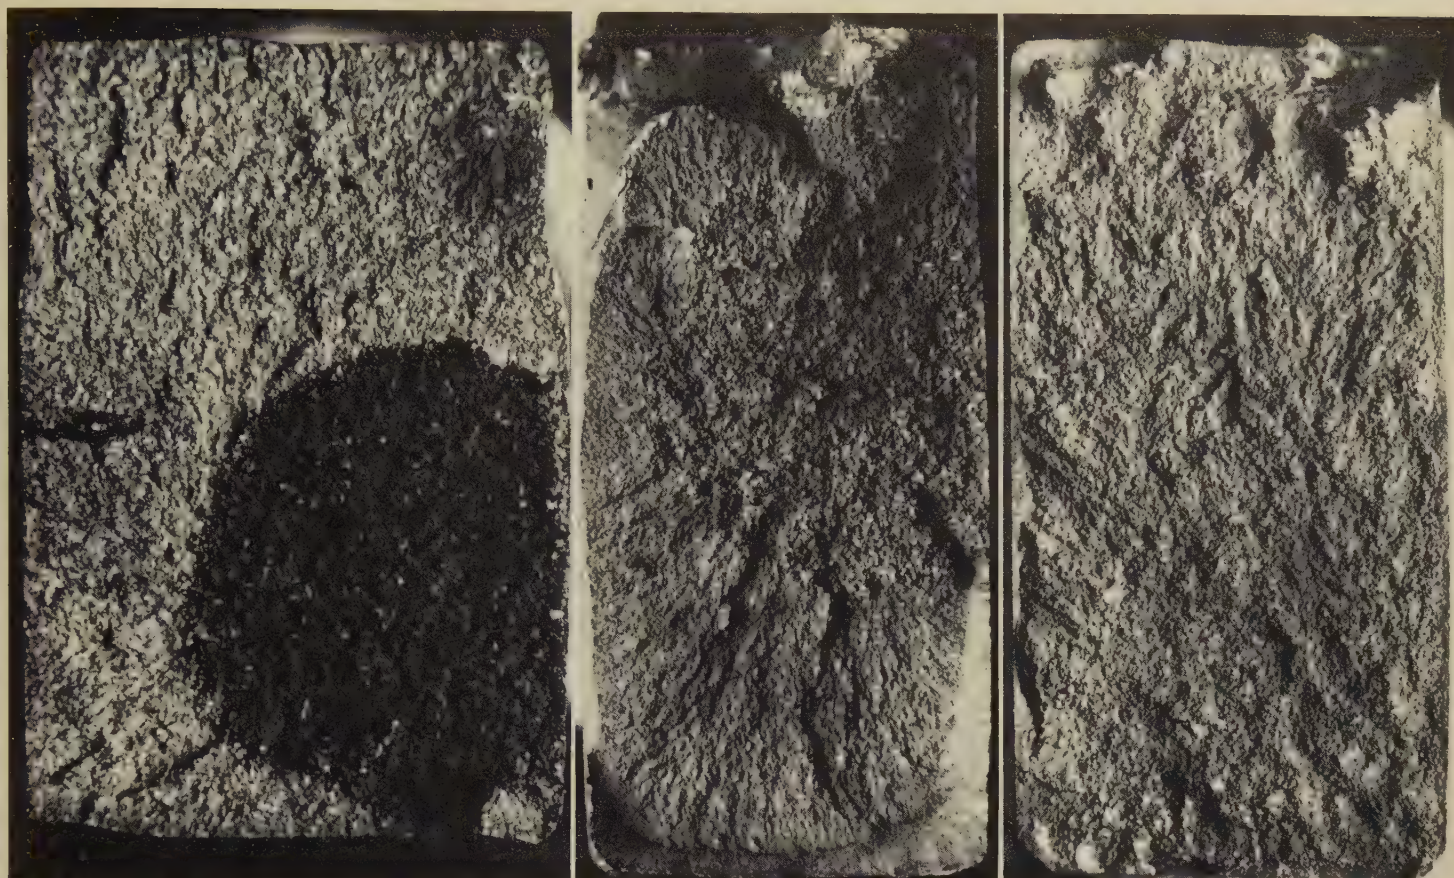
5102, 5103, 5104

Surfaces of fractures in three type 410 stainless steel links of a conveyor chain used in a food-processing operation. Heat treatment of the links had included box annealing at 996 C (1825 F) for 1 hr, oil quenching, and tempering between 260 and 371 C (500 and 700 F) for 2 hr. Measured hardness was Rockwell C 37 to 44. Service conditions included cleaning in water containing 2 ppm of chlorine at 70 C (158 F), cleaning in saturated steam at 120 C (248 F), cleaning in air at 120 C (248 F), and water cooling at 20 to 32 C (68 to 90 F). At left (5102) is the dark, oxidized surface of a heat-treat crack; the remainder of the fracture surface is brittle and shows no shear lip. At center (5103) is a heat-treat crack (at top edge) and a shear lip (at bottom edge), with fast fracture between them. At right (5104) is a very small heat-treat crack (right side of top edge) and portions of a shear lip (at left edge and at top edge left of crack). See also micrographs 5105 through 5107 (below).

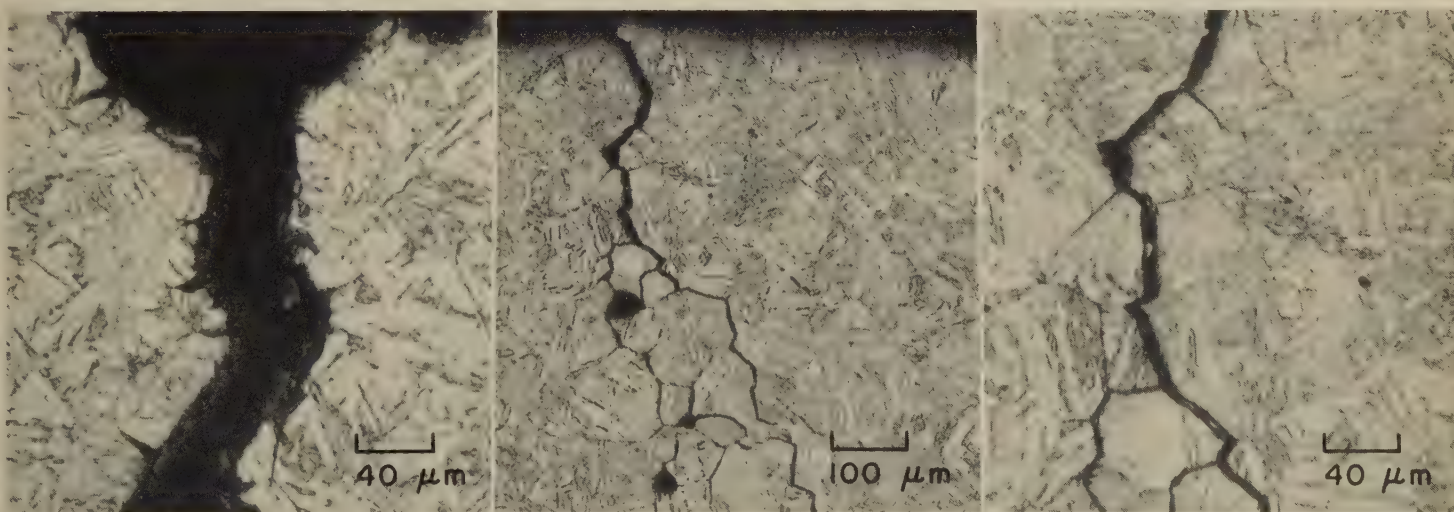
Polished and etched sections through secondary heat-treat cracks branching from the primary fractures in the conveyor-chain links in 5102 and 5104 (above), showing the intergranular nature of the cracks. At left (5105) is a crack in the link in 5102. Note that the surfaces of this crack have oxide coatings; the short cracks branching from it were oxide induced. At center (5106) and at right (5107) are views, at different magnifications, of a secondary crack in the link shown in 5104. Again, oxide is present within the crack, as can be seen somewhat obscurely in 5107. Note that this crack has branched to connect with nonmetallic inclusions. It is evident, from the presence of oxide on all crack surfaces, that both primary and secondary heat-treat cracks formed before the links were oil quenched from the annealing temperature.

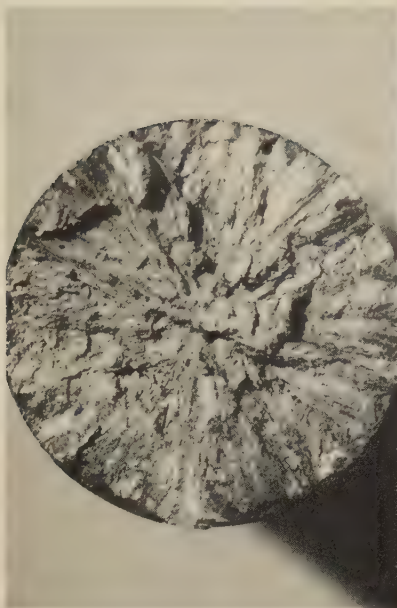
Light fractograph 7×
5108 Surface of a fracture in the stem of an automotive valve cast of austenitic steel (0.85 C, 2.5 Si, 16.5 Cr, 14.5 Ni, 1.0 max Mo, 1.0 max Cu, 3.0 max Co). Note woody appearance, which is characteristic of fractures in castings.

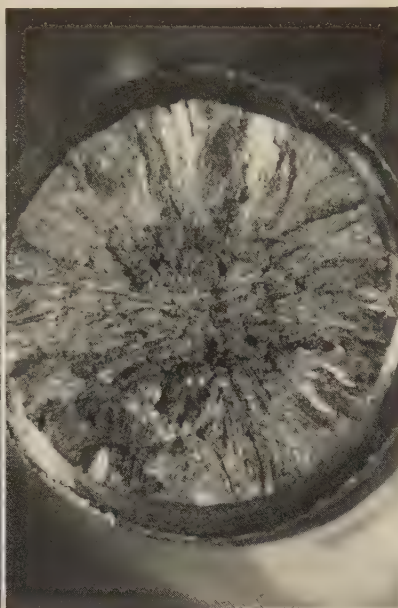
Light fractograph 7×
5109 Surface of a fracture in the stem of an automotive valve that was cast of the same austenitic steel as in fractograph 5108. The hardness of the valve was Rockwell A 59. Note the shrinkage porosity and dendrites at center.

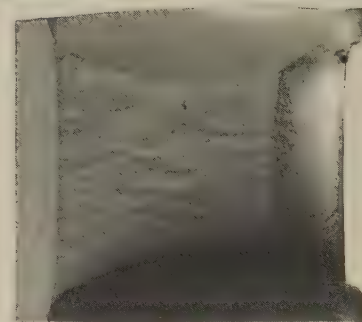
Light fractographs All at about 1 1/3×
5110, 5111, 5112 Fractures in three 13-8 PH stainless steel fracture-toughness specimens aged 4 hr at 538 C (1000 F) to a yield strength of 1379 MPa (200 ksi). Specimens in 5110 and 5111 (from 10-in.-square stock), at top, and specimen in 5112 (from 6-in.-square stock), at bottom, had K_{Ic} of 120 and >142 MPa·m^{1/2} (109 and >129 ksi·in.^{1/2}), respectively.

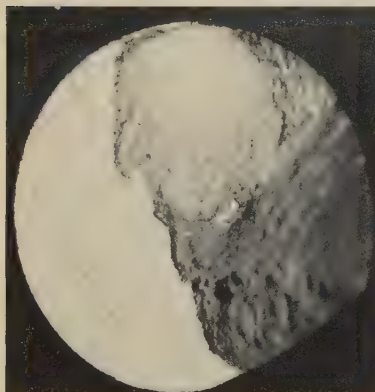
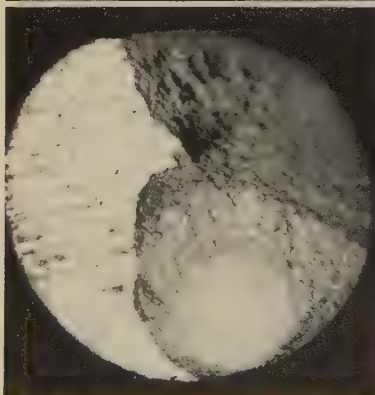
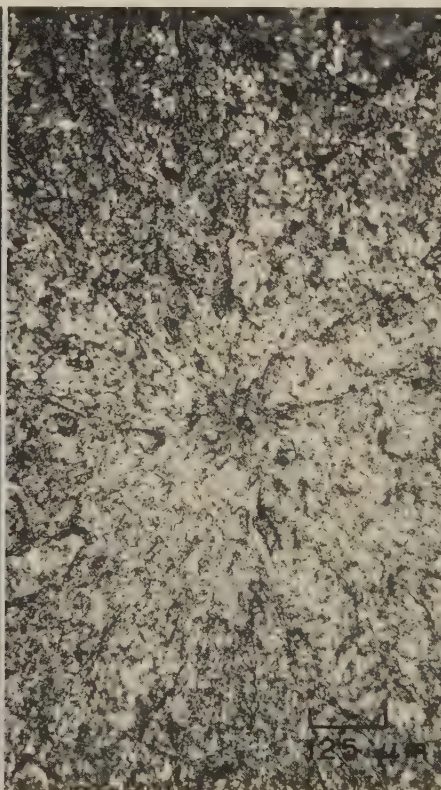
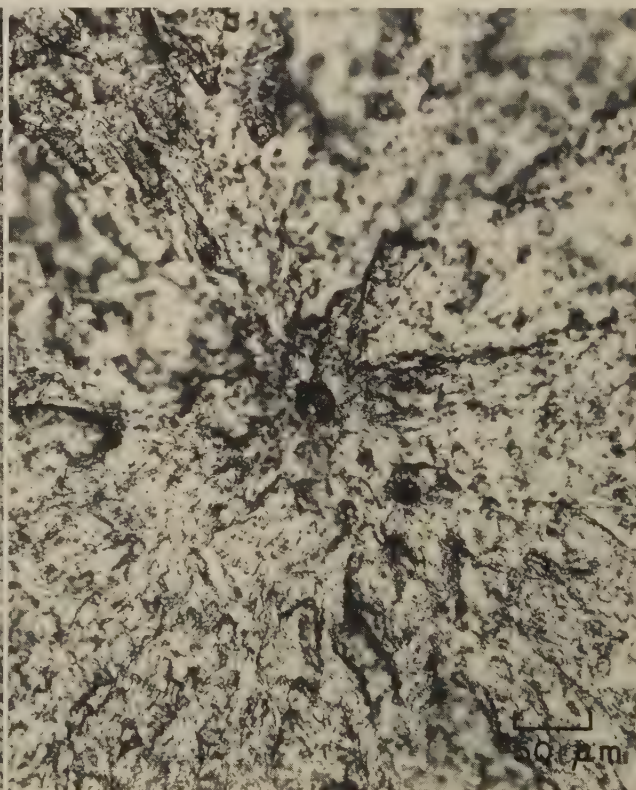
Light fractographs
5113, 5114, 5115, 5116

8× Light fractograph 80× Light fractograph 200×
At left (5113 at top, 5114 at bottom) are the mating fatigue-fracture surfaces of a specimen of 15-5 PH stainless steel heat treated to a yield strength of 1103 MPa (160 ksi). The specimen was tested in tension ($R=0.1$) to a maximum stress of 896 MPa (130 ksi); fracture occurred after 8.7 million cycles. At left in each view is a light area containing grinding marks, where a jagged portion of the region of final, fast fracture was removed to facilitate photography. The fatigue crack originated at the center of the light, circular zone visible in each fracture surface. Fractographs 5115 (center) and 5116 (right) are higher-magnification views of the fracture surface in fractograph 5114. These views show that the fatigue crack originated at an inclusion.

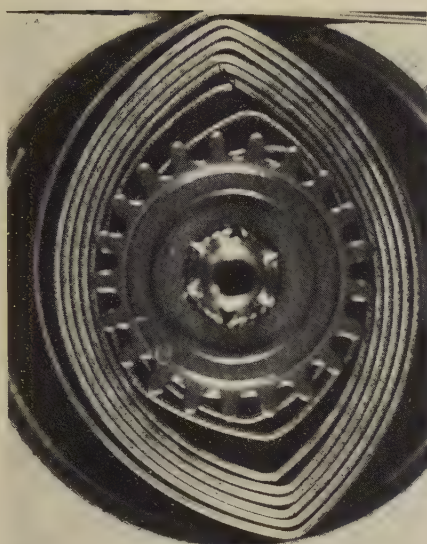
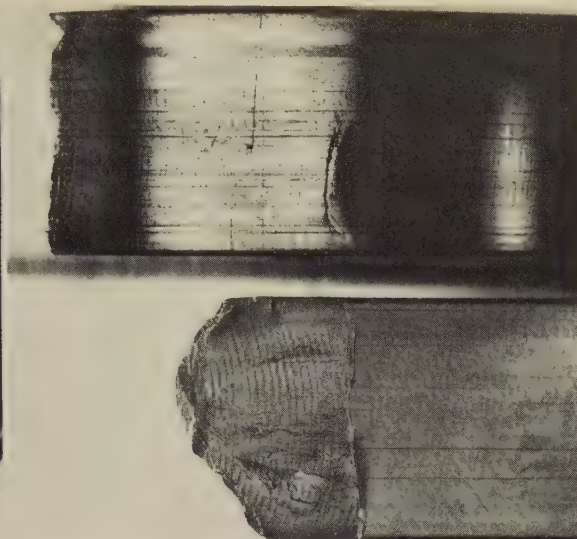
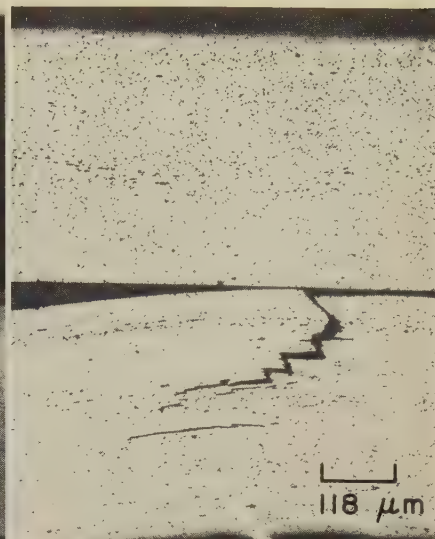
5117, 5118, 5119

At left (5117) is a view of a broken spiral instrument spring of cold worked type 302 stainless steel flat wire. Hardness at the surface was Rockwell C 45; internal hardness was Rockwell C 53. All fractures in the spring originated at outer, or tension, surfaces. The initial fracture, which was by fatigue and which occurred at the first or second innermost turn, placed point-contact pressure on the adjacent turn, which then broke, producing consecutive fractures in the remaining turns. At center (5118) are two surfaces of the spring — a tension surface (top) and a compression surface (bottom). The tension surface shows vertical ripple marks (which are superficial and can be removed by light polishing), a fracture surface in profile at left, and an incipient fracture at right. The compression surface shows a fracture containing fatigue beach marks. At right (5119) are two polished and electrolytically etched (10% oxalic acid) sections through the spring — a transverse section (top), and a longitudinal section (bottom) showing centerline microcracks. No definite metallurgical cause of fracture was discovered; however, higher hardness in the interior than at the surface is very unusual, and the centerline microcracks may have been a contributing factor.

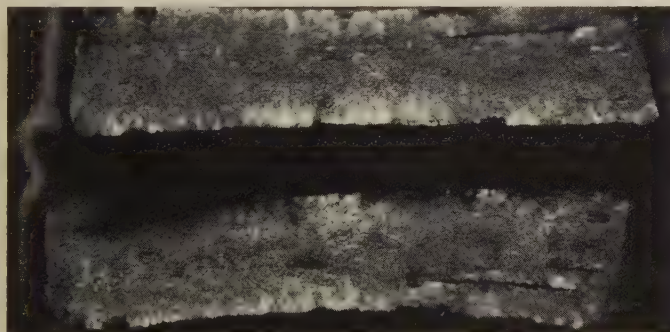
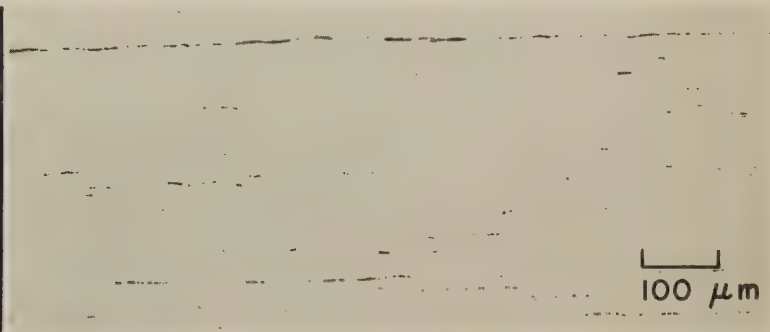
5120, 5121

At left (5120) are the mating surfaces of a fracture in a transverse tensile-test specimen of annealed type 304 stainless steel sheet, showing longitudinal cracks. The cracks were attributed in part to laminations caused by severe forming and in part to the stringers of nonmetallic inclusions visible in the polished longitudinal section in 5121 (right).

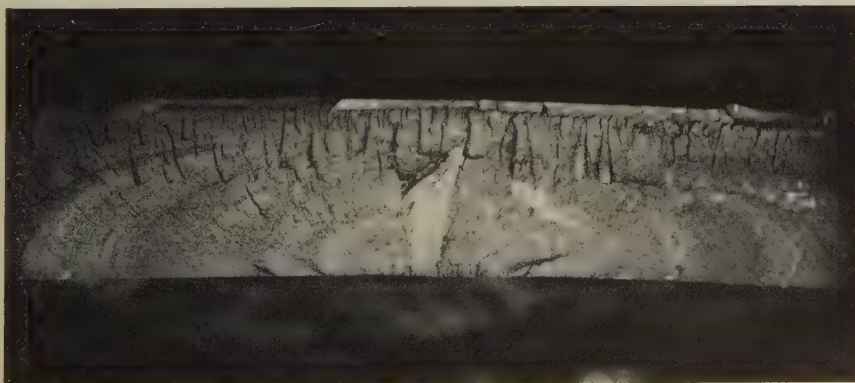
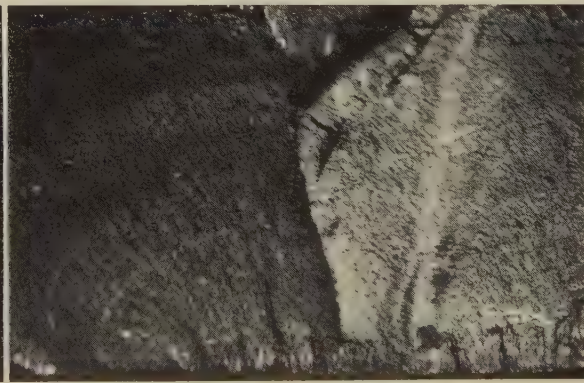
5122, 5123

Views, at different magnifications, of the surface of a fatigue fracture in a welded fan blade of type 330 stainless steel. Clearly evident are beach marks typical of fatigue. Multiple fatigue cracks, which were initiated by columnar cracks in the weld area at the center of the bottom edge, penetrated a short distance into the blade before uniting to form a single crack front. The columnar cracks in the weld area were attributed to microfissures, which had resulted from improper welding practice.

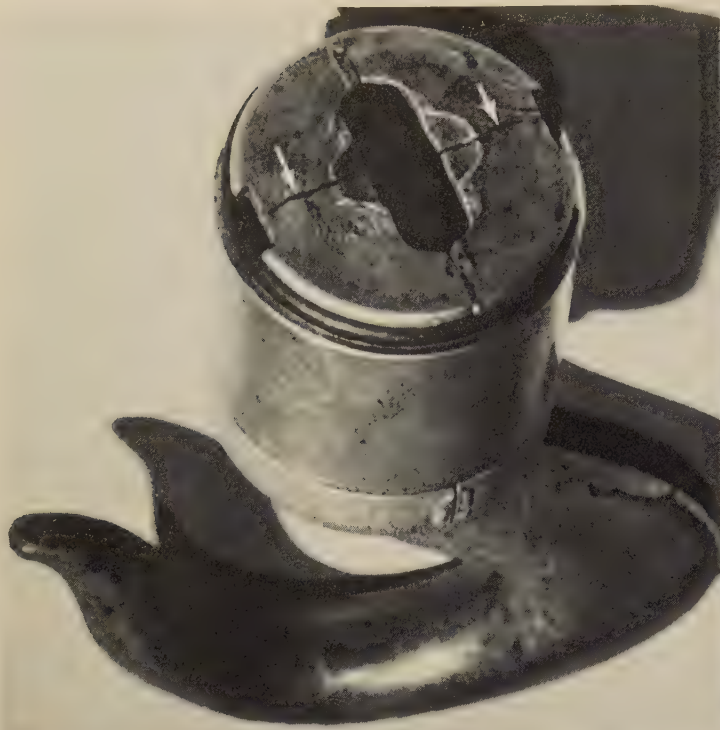
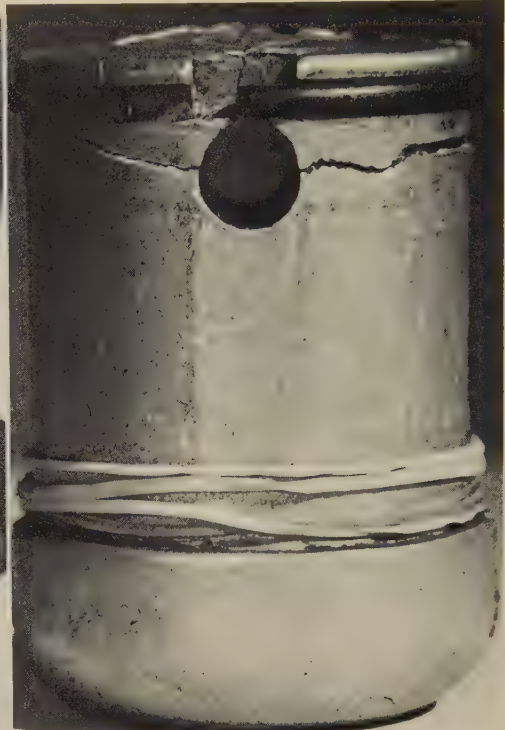
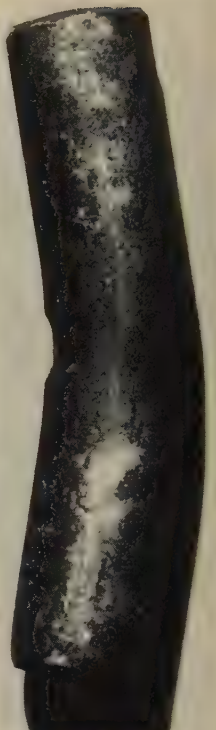
5124, 5125, 5126 Fractures in a die cast aluminum alloy 218 housing of a chain-hoist hook, which is believed to have broken by overload in service. At left (5124) is a view of the reassembled hook components, showing a transverse fracture (arrows) in the top surface of the housing. This fracture, which preceded and instigated final fracture of the housing, was above and parallel to a steel retaining pin (shown in 5126, at far right), which secured the hook to the hoist chain. At center (5125) is a side view of the housing, which consisted of two pieces held together by the retaining ring visible at top, showing the final fracture (roughly horizontal), the deformed retaining-pin hole (elongation of about 3% is indicated — a reasonable value for this alloy), and one end of the fracture in the top surface. See also fractographs 5127 (below) and 5128 (on facing page).

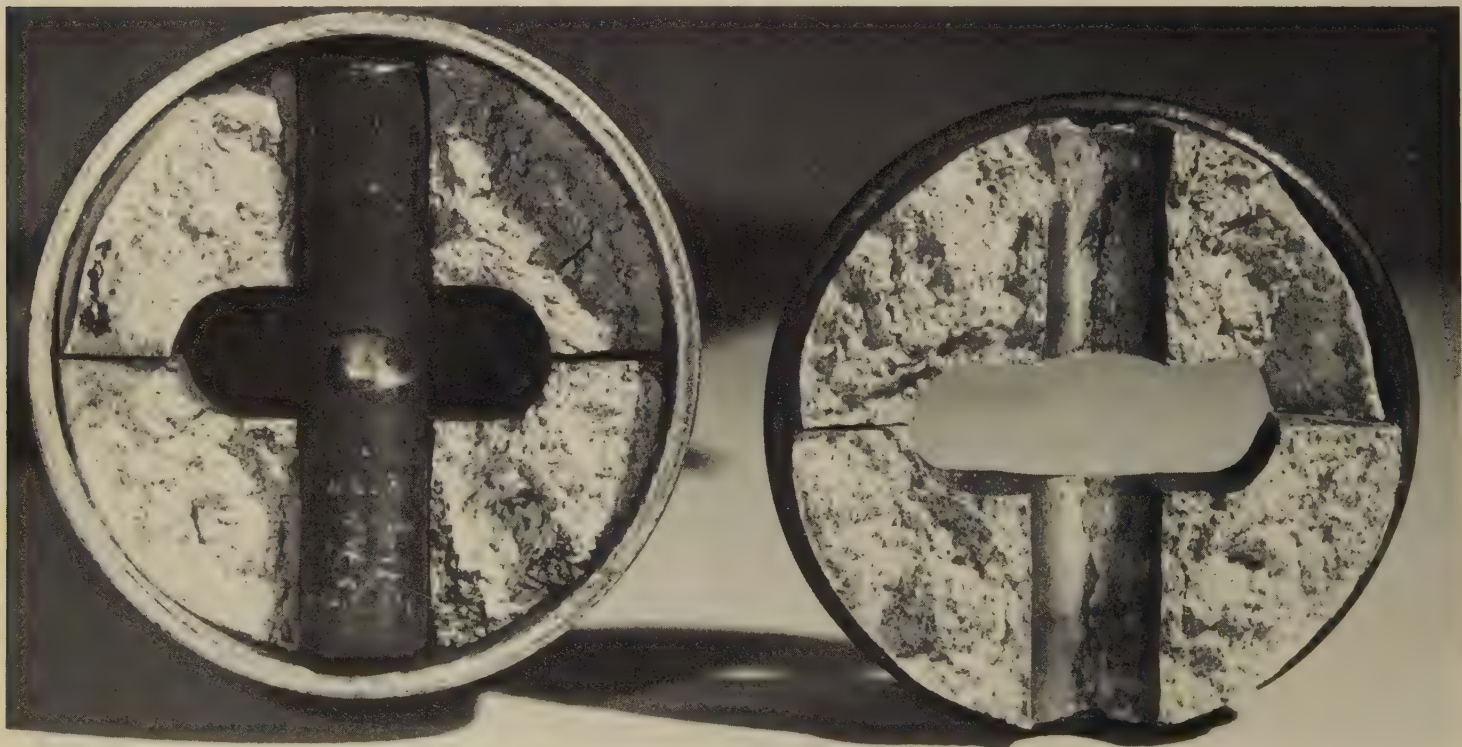
5127 Mating surfaces of the fracture in the side of the housing in 5125. At right is the upper surface, with the retaining ring (shown at top in 5125) still in place; visible in the bore of the retaining-pin hole is the fracture in the top surface of the housing (see 5124). At left is the lower surface, with the retaining pin in place inside a collar.

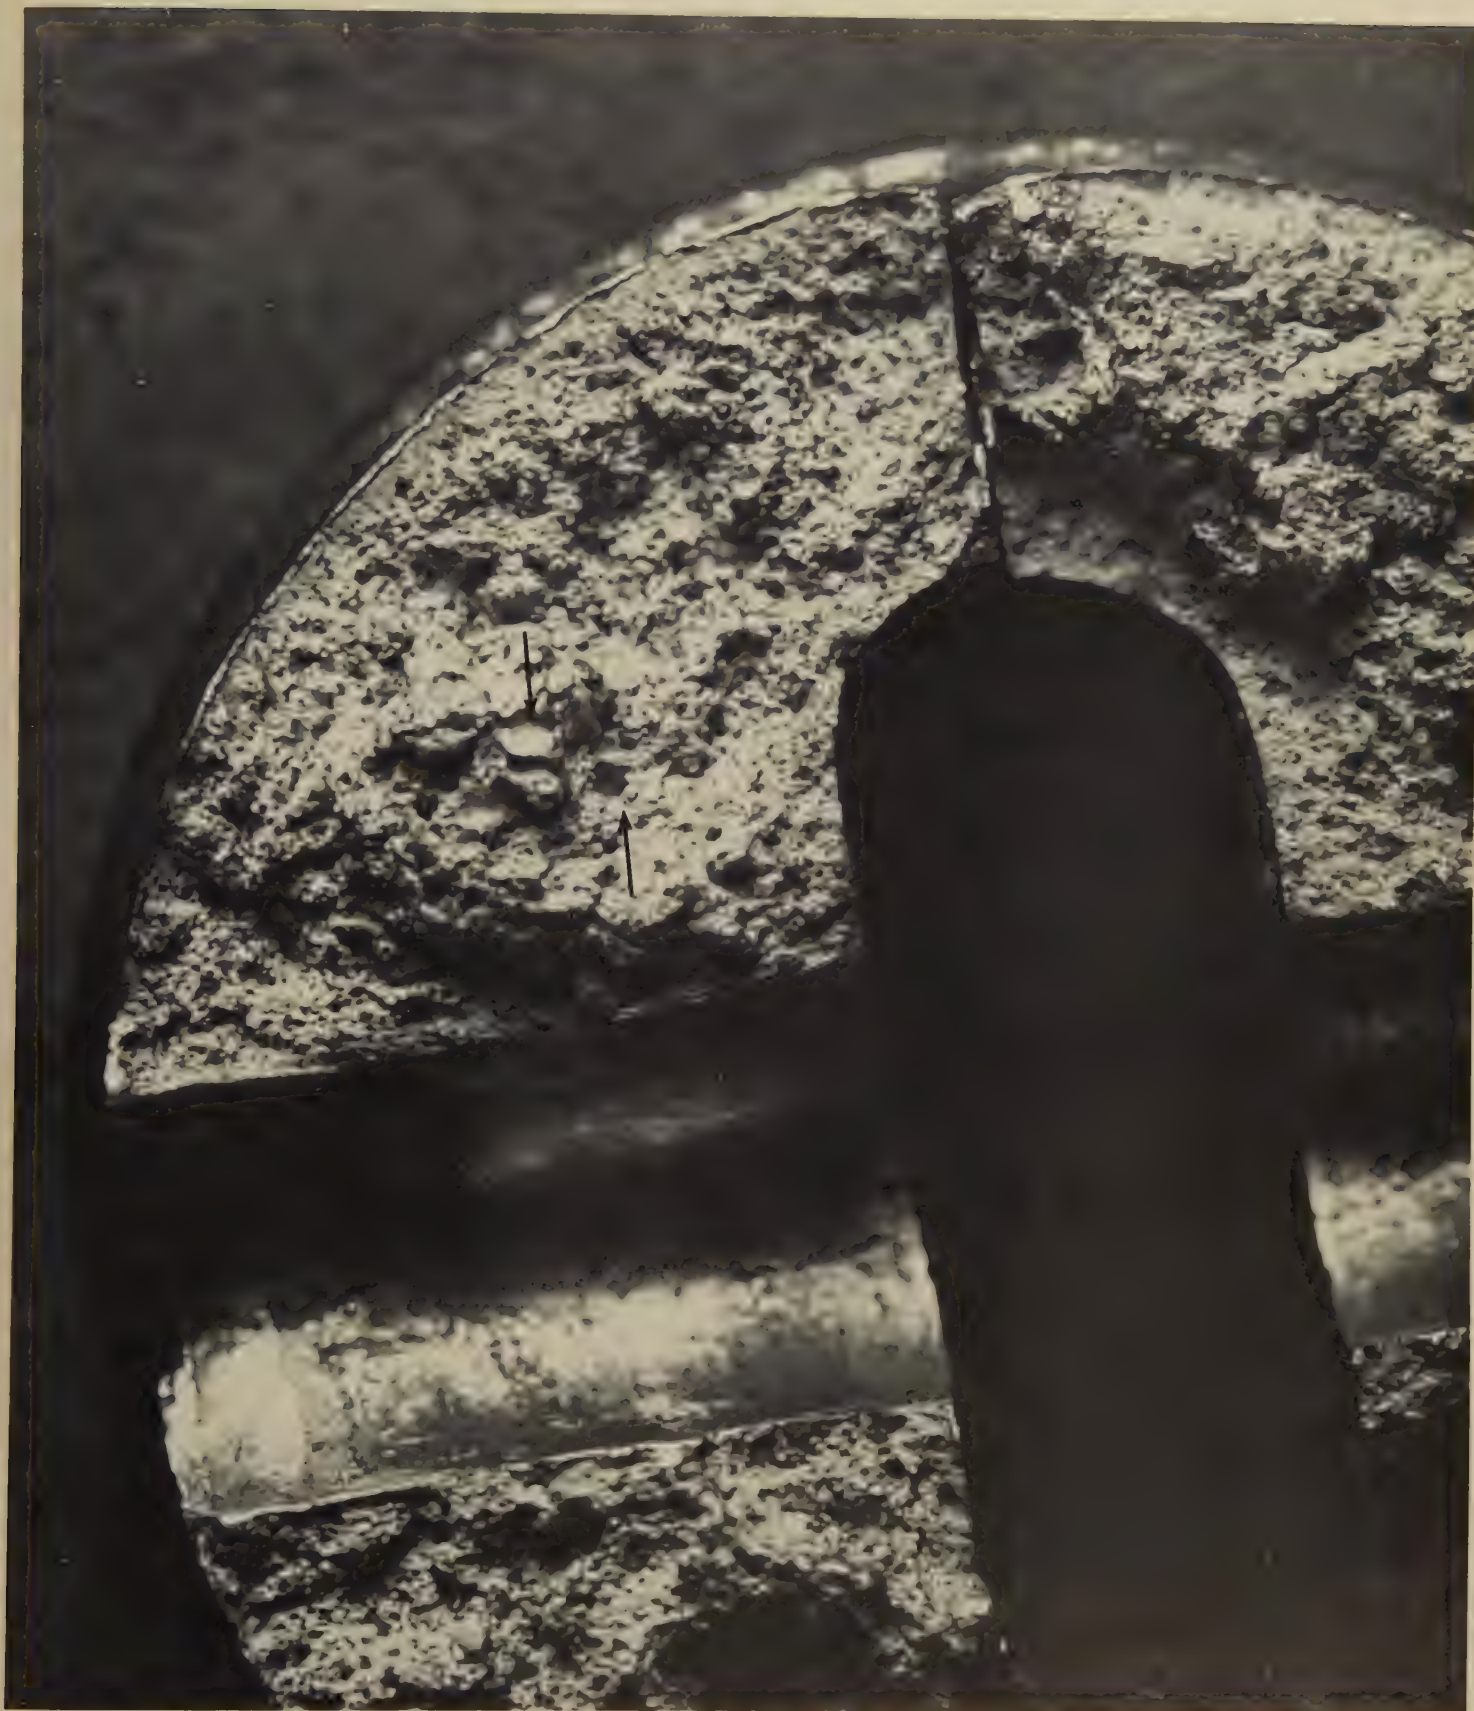
5128 Enlarged view of the lower left portion of the top fracture surface (shown at right in 5127) of the broken die cast housing in 5124. Note gas cavities (at arrows), which are common interior features of satisfactory die castings. Bending of the retaining pin (see 5126) is believed to have occurred after the transverse fracture of the top surface of the housing caused relocation of the load-bearing points on the pin. Low-cycle fatigue would have been a likely cause of fracture, but no fatigue beach marks could be found.
